Successful Safety Strategies at Signalized Intersections In Holland and Port Huron

Michigan Traffic Safety Summit

February 28, 2006

URS

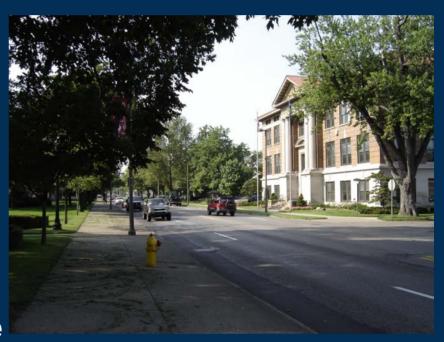
River and Michigan Corridor; Holland

- Typical urban 4-lane corridor
- Feeds Downtown Holland and crosses Black River
- Narrow (10') lanes, ROW constrained
- Significant turning traffic, no exclusive left-turn lane

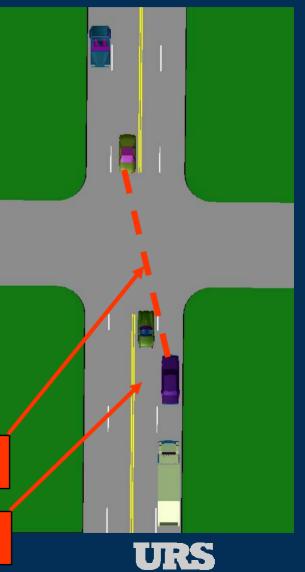
Left-turn Movement Visibility

- Off-set left-turn compromises left-turn movement visibility
- High number of right-angle crashes
- Through traffic weaves around left-turning traffic
- High number of rear-end crashes

Poor Sight Distance

Additional Stops

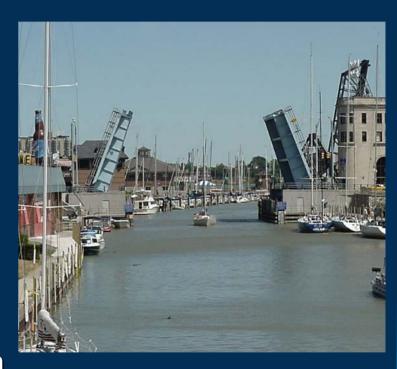
Safety Strategy – Traffic Signal System

- Optimized traffic signal timings
- Signal timing adjustments during bridge events
- Bridge status indicator lights at fire and police stations
- Fire station indicator lights in bridge houses

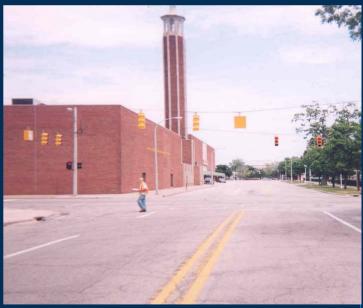
Safety Strategy – Traffic Signal Enhancements

Installation of box span signal configuration at 15 locations

Replacement of 8" signal lenses with 12" lenses at 10 locations

Updated yellow and all-red clearance intervals

Conversion from 4 lanes to 3 lanes at 4 intersections

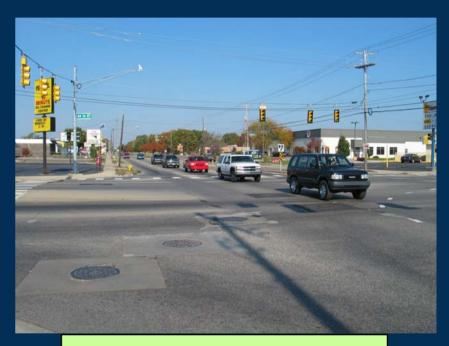
44th Street at Clyde Park

Driver Behavior Study; Wyoming

- Evaluate impact to driver of distance to signal face
- Red light violation rate
- Late yellow entry (last second of yellow) rate
- Before & after study

Measure	Before	After
Red Light Violation Frequency (per day)	5.5	0.9
Red Light Violation Rate (entering through vehicles)	1 per 900	1 per 4700
Late Yellow Entry Frequency (per day)	20	2.5
Late Yellow Entry Rate (entering through vehicles)	1 per 250	1 per 1600

- 81% reduction in red light violations
- **♦ 84% reduction in late yellow entry**
